CURRENT CONDITIONS OF LARGE DAMS IN BOSNIA AND HERZEGOVINA

Slobodan Kovačina, B.Sc.Civ.Eng.¹, Dženan Malović, Dipl.Ing.El.Eng.²

¹ENCOS d.o.o. Sarajevo, ²IFC, World Bank Group, Sarajevo Office

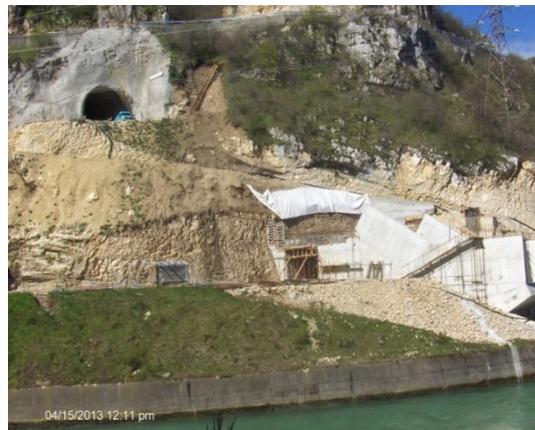
Fig. 2: Additional discharge facilities – construction site

Hydrological analyses, carried out in year 2000 within a framework of the conceptual design phase of the downstream located projects HPP Krupa and HPP Banja Luka, resulted in design flood values for various return periods that were significantly different from the original estimates. According to these hydrological analyses, the 1000-year flood for Bočac Dam was estimated to be $2073 \text{ m}^3/\text{s}$, which is about 40% higher than the 1000-year flood of $1490 \text{ m}^3/\text{s}$ derived during the original design. It was concluded that the new design flood exceeds capacity of the existing discharge facilities, which would lead to the dam overtopping with unknown consequences in a case of such flood occurrence.

As a consequence, an 80 m long free crest side spillway on the left side is being constructed (Fig. 2). The spillway is activated as soon as the reservoir rises to the maximum flood surcharge elevation. A 5.0 m diameter discharge tunnel curves and transitions into a chute located on the right abutment, then crosses the access road and ends with a jump. At the 2.5 m head (which is 0.5 m lower than the dam crest elevation) the side spillway and discharge tunnel can pass 580 m³/s, which is equal to the capacity deficit of the existing discharge facilities.

Eventually, the option (3) has been selected and is currently being implemented.

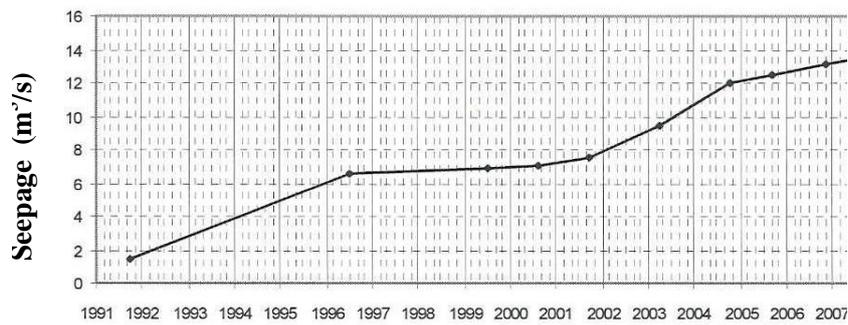
Fig. 3: Change in seepage with time

The monitoring and research program resumed after the war in 1996, and it was revealed that both the number and yield of boils have significantly increased. Measurements carried out in 2008 indicated that the seepage amount have increased tenfold to 14 m³/s (Fig. 3).

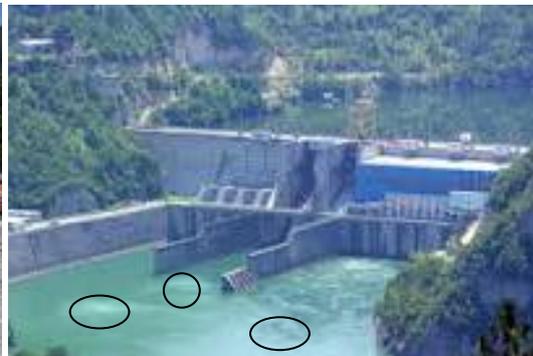
During the reservoir test-filling, while the grout curtain was being completed, the occurrence of boils was noticed in the river bed downstream of the dam. Water coming from these boils was turbid indicating the connection of boils to the seepage from the reservoir. The design team developed and undertook monitoring program to analyze these phenomena and simultaneously enhanced the grout curtain with additional grout holes in order to ensure stability of the dam. The results of monitoring program indicated that the seepage zone was located under the grout curtain (i.e. its segment #5), and the seepage amount was 1.40 m³/s. All further activities were stopped in 1992 due to the commencement of war in BiH.

Fig. 5: Boils in the river bed downstream of the dam

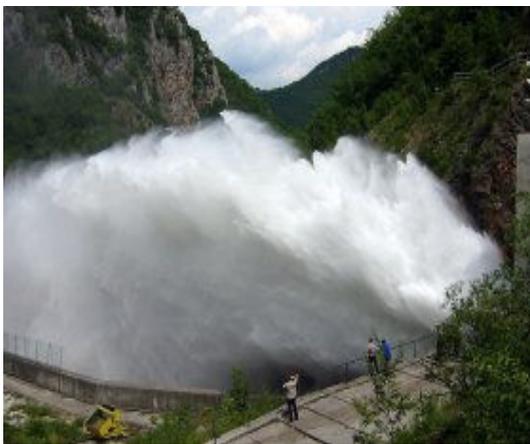
Rama Dam has a fairly unusual layout of its low level outlet. The direction of the outflow jet from the low level outlet is parallel to the downstream toe of the dam. Therefore, when the low level outlet operates, the outflow jet either lands parallel to the toe of the dam, or hits the opposite river bank. Since HPP Rama power plant was not operating for a significant amount of time during the 90s war, the reservoir level was controlled by low level outlet only. This means that the low level outlet was operating almost permanently during that

period, which resulted in some soil degradation in the vicinity of the toe of the dam and consequent danger to the dam stability.

Fig.6: Low level outlet in operation

- Improvements and repairs on penstock and surge tank;
- Reinforced concrete jet deflectors were built to direct high pressure low level outflow discharges;
- River bed between low level outlet and the dam left abutment was lined with concrete;
- Both the left abutment foundation and the dam concrete face were repaired;
- The grout curtain was repaired.
-

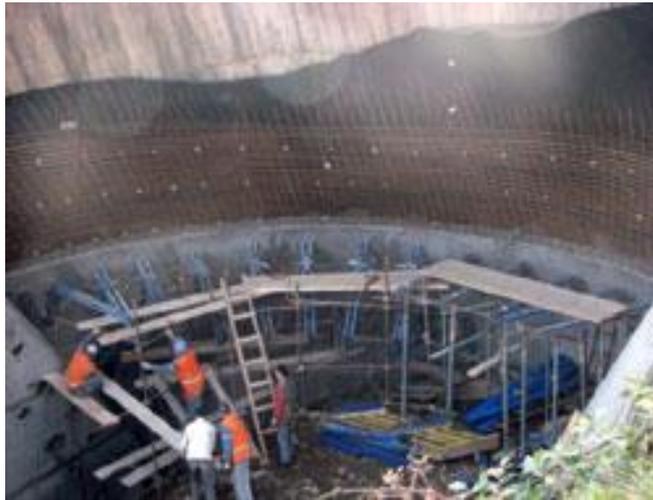
This is a reinforced concrete multiple-arch buttress dam with 9 buttresses and 10 arches. The dam crest is 205 m long, maximum dam height is 205 m, and the thickness of the arches ranges from 0.40 to 0.50 m. Due to various stresses and climatic influences, the reinforced concrete arches experienced damages, especially at locations of their contact with buttresses. Due to this fact, it was decided in 2000 to start research activities and preparation of technical documentation with the aim to find the best solution for rehabilitation of the dam. During the first phase of the rehabilitation works the arches 1, 2 and 3 were repaired, and in the second phase the dam foundation and the arches 8, 9 and 10 were repaired.

Fig. 9: Repairs of the arches
