PUMPED STORAGE HYDROPOWER PLANT AVČE – CONSTRUCTION OF UPPER STORAGE RESERVOIRS WITH TWO DAMS AND TECHNICAL MONITORING

This article will present the construction of upper storage reservoir with two dams and installed technical monitoring.

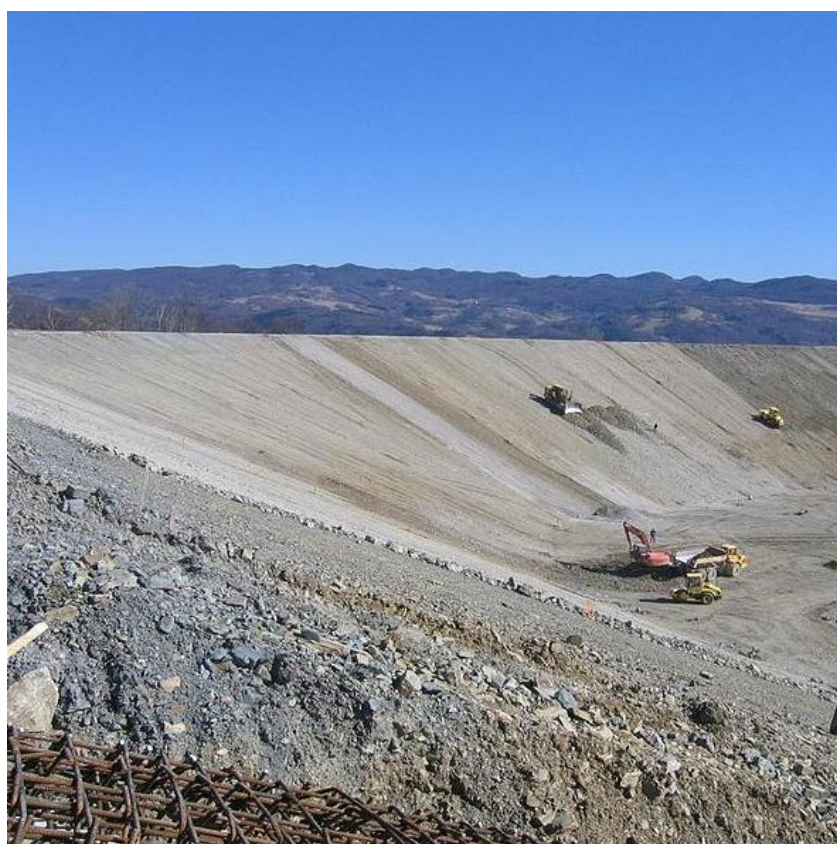
Picture 2 Building of larger dam

Accumulation is positioned in Karst valley. The valley was deepen and closed with two 25 meter high dams. The bigger dam is approximately 400 meters long and the smaller is 200 meters long. The sealing of the accumulation was made from special asphalt, which was laid on tampon layer from crushed stone material.

The grounds are made from karsted flysch. Flysch consist layers of softer (marlstone and claystone) and harder rocks (sandstones and limestone). The excavation was conducted with bulldozers and excavators. Occasionally the mining was necessary. The excavated material was mixture of gravel and clay. The classification was GC-GM with large rocks.

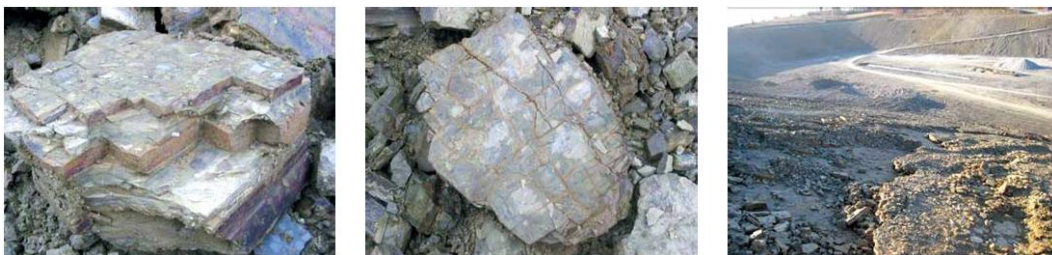
Picture 3 Weathering of the flysch

The picture 3 shows the weathering of flysch. First it disintegrates in smaller blocks and gravel. After a while it disintegrates in clay. Time of disintegration is from few days to few months.

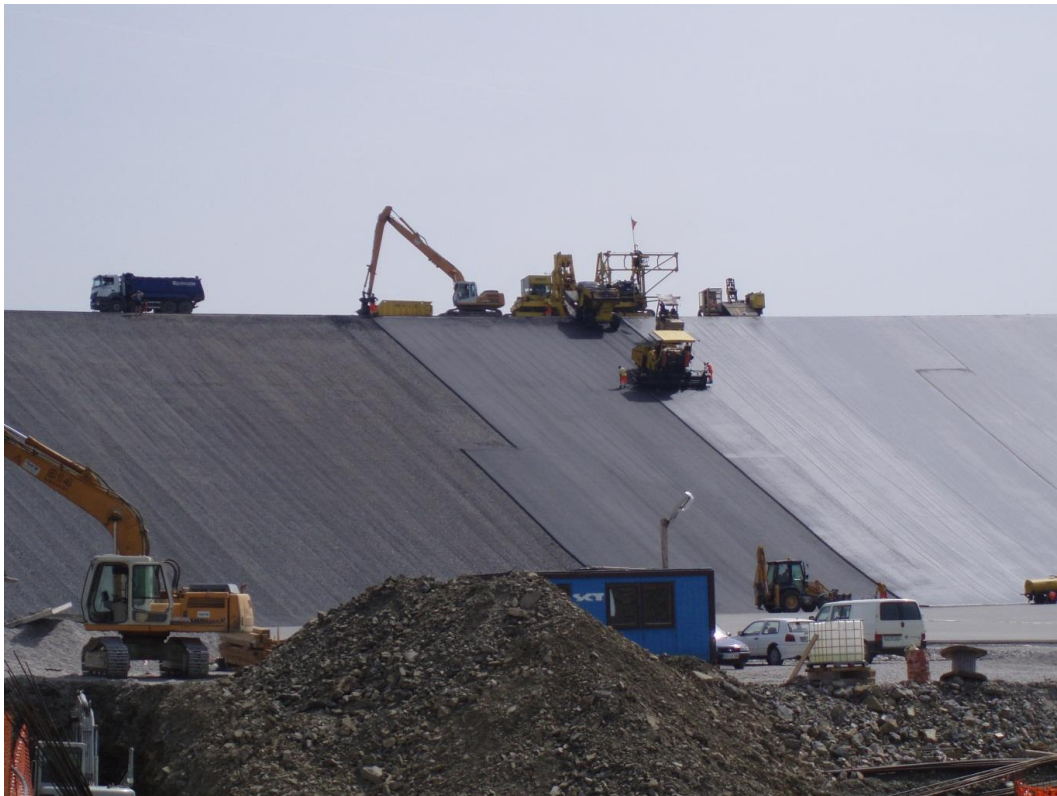
Picture 6 Asphalt laying

The asphalt was produced in the asphalt plant as described above and transported by suitable tippers to the slope and the first roller. The winch supports the paver, the feeding wagon in the slope and the first roller. The winch is movable on tracks and is placed at the crest. The tipper dumped the asphalt into an isolated container. There it was loaded by a long reach excavator to the feeding wagon, which transported and tipped the asphalt to the paver.

The paver operates on tracks in the slope and places the asphalt in vertical strips from dam toe including the radius up to the crest. The paver is equipped with the high compaction screed of variable up to 5 m. at the open side of the paver a forming and compaction shoe ensured a compaction of the complete strip.

The capacity of the feeding unit did allow a permanent and high performance placing. The paver and the wagon are pulled into the main winch itself. By this system a mechanised placing was done to the very top of the crest. The main winch including the mounted paver and wagon then moved sideward and the placing continued at the adjacent strip.

The first roller was supported by the main winch. It did compact the asphalt layer immediately. A second roller followed, which is supported and secure by mobile roller winches. The rollers were pulled up onto ramps at the winches and did compact the asphalt layers up to the crest. The compaction did continue until the required compaction ratio was achieved.
