IMPLEMENTING PASSAGES FOR LIVING ORGANISMS ON DAMS ON THE RIVER DRAVA

Alenka Prnaver, dipl.inž.grad.

Dravske elektrarne Maribor, Obrežna 170, Maribor, Slovenia

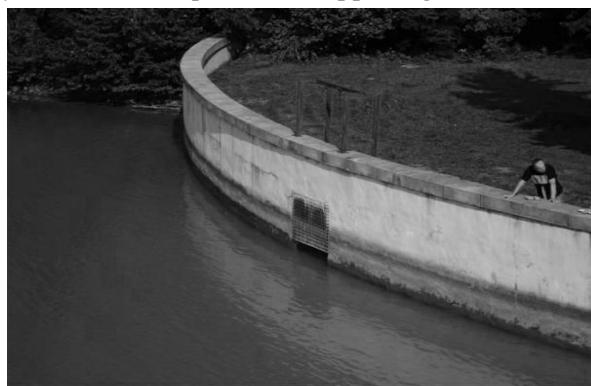
Picture 2 Inflow of fish passage on the left side of Mariborski otok HPP

Monitoring of the fish passages for several months has lead to conclusion, that the inflow of fish passage is too high for current operation of hydroelectric powerplants and this consequently prevents constant flow of water in fish passage.

- Construction of new inflow, which is approximately 0,75 m lower to ensure constant flow of water and in this way, wettability of fish passage.
- Arrangement of fish passage outflow by elevation of walls at the outflow area of fish passage. The height of the walls must be approximately 20 cm higher than the maximum operational level of lower waters. To ensure appropriate water depth in outflow area, vertical walls should be inserted
- The floor of fish passage should be adapted for aquatic invertebrates. The design should increase the roughness of the floor and in this way partially improve hydraulic conditions at lower flow rates.
- Hydraulic conditions in the fish passage should be improved
 - reduce the speed of water flow by placing barriers.

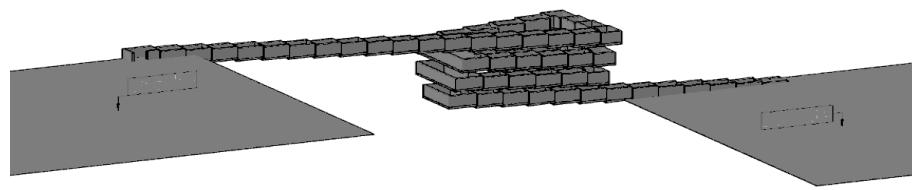
Basic demands for form and dimensions of existing fish passage were based on the evaluation of AG-FAH (2011) and FAO & DVWK (2002). The results show, that the geometry of fish passage does not match modern requirements in at least four parameters. The consludion of the study recommends reestablishment of current object with recommendations that are to be implemented in steps and evaluated with monitoring. Additionally, hydraulic test was performed as part of the study.

Picture 3 Fish passage geometry at Mariborski otok HPP

Splošno:	Ribja steza Mariborski otok	AG-FAH, 2011	FAO & DVWK, 2002
disipacija energetike (W/m ³)		100,0	150,0
max.višina stopnje (cm)	25,0	10 do 13	20,0
max. naklon (%)	8,0	4,2	
volumen kotanje (m ³)	5,5	7,0	3,2-6,0
Režasti prehod:			
min. širina reže (cm)		35,0	30,0
min. dolžina kotanje (cm)		310,0	275-300
min. širina kotanje (cm)		210,0	180,0
min. globina vode - tolmin (cm)		105,0	75,0
min. globina vode - reža (cm)		111,5	
pretok (l/s)		550,0	410,0
dolžina roba-c (cm)			18,0
zamik-a(cm)			14,0
širina usmernika-f(cm)			40,0
Stopničaste kotanje:			
min. širina odprtine (cm)	40,0		40-50
min. višina odprtine (cm)	40,0		30-40
max. hitrost v odprtini (m/s)	> 2,0		2,0
min. dolžina kotanje (cm)	260,0		250-300
min. širina kotanje (cm)	145,0		160-200
globina vode (cm)			80-100
pretok (l/s)			200-500

Picture 4 Results of the existing fish passage analysis

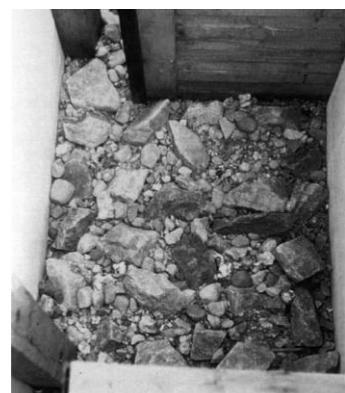
- Redesign fish passage into a gap passage – the water flows from basin in the basin through the slots, which are open on the entire height of barrier wall. This allows the passage for species that are weak swimmers and those living on the floor, it is less it is less sensitive to fluctuations in the depth of water in the fish way and has less chance of clogging.

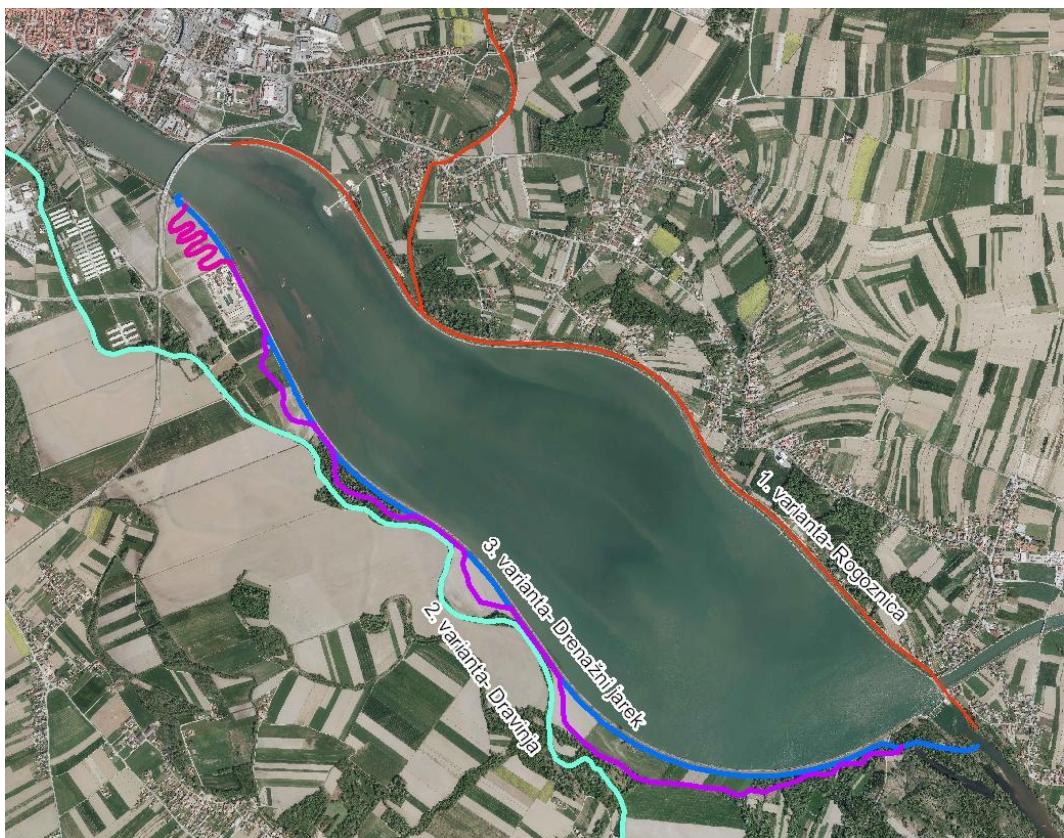
Picture 5 Variant solutions of passages for living organisms for the Ptuj Lake (Markovci dam)

1. varianta – Rogoznica (red line) = Variant 1, drainage channel Rogoznica

2. varianta – Dravinja (cyan line) = Variant 2, Dravinja River

3. varianta – drenažni jarek (magenta line) = adopted Variant 3

Blue line represents an existing right-bank drainage channel

- 1) Optimization of three basic variants, evaluated variant 3 as the most appropriate, i.e. right bank with drainage ditch and third subvariant of exit gateway under Puh's bridge

- 2) Entrance to gateway for aquatic organisms and attraction remain open.
- 3) For the proposed variant 3, it is necessary to solve the problem of water release from Č.N. in the drainage ditch and properly clean contaminated sediments from the drainage ditch.

- 4) Drainage ditch must be edited in the length of approximately 5.1 km.
- 5) In order to equalize the water temperature in the gateway for aquatic organisms and the Drava River, part of the pouring section of gateway for aquatic organisms must be built waterproof (separation from the cold ground).
