CURRENT CONDITIONS OF LARGE DAMS IN BOSNIA AND HERZEGOVINA

Slobodan Kovačina, B.Sc.Civ.Eng.¹, Dženan Malović, Dipl.Ing.El.Eng.²

¹ENCOS d.o.o. Sarajevo, ²IFC, World Bank Group, Sarajevo Office

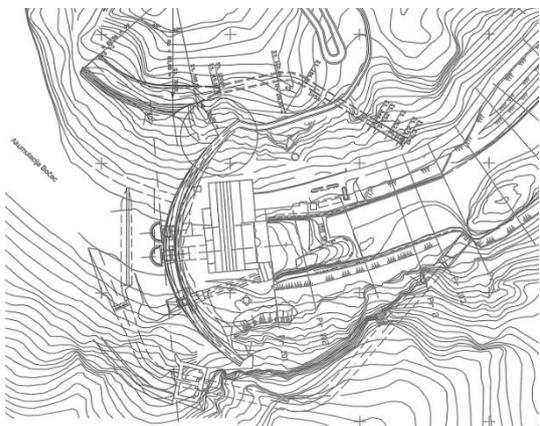
Fig. 1: HE Bočac layout

Flood discharge facilities consist of a 2-bay side spillway equipped with radial gates and a discharge tunnel, which was used as a diversion tunnel during the construction (Fig.1). Flood discharge facilities have been designed for the 1000-year return period and their combined capacity, including the low level outlet, at maximum flood surcharge reservoir elevation (which is 1 m higher than the maximum normal elevation) is $Q_{0.1} = 1490 \text{ m}^3/\text{s}$.

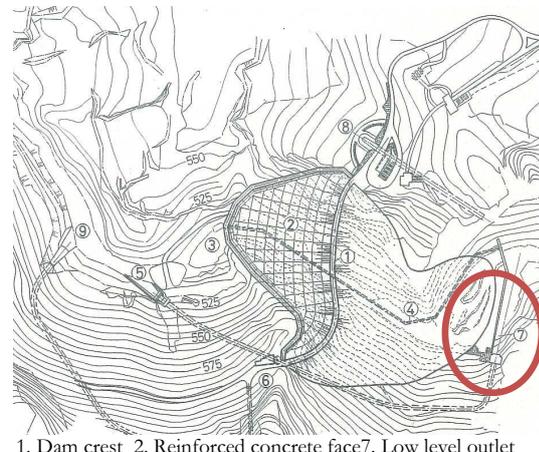
Fig 7: Rama dam layout

1. Dam crest 2. Reinforced concrete face 7. Low level outlet

- Improvements and repairs on penstock and surge tank;
- Reinforced concrete jet deflectors were built to direct high pressure low level outflow discharges;
- River bed between low level outlet and the dam left abutment was lined with concrete;
- Both the left abutment foundation and the dam concrete face were repaired;
- The grout curtain was repaired.
-

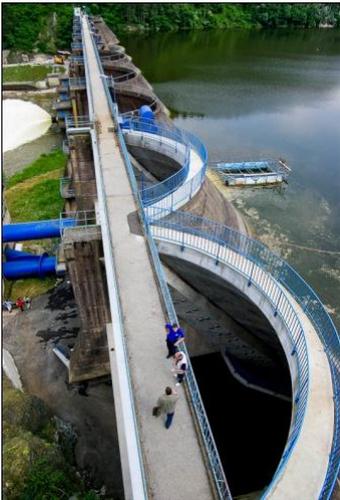
Fig. 8: Modrac Dam

This is a reinforced concrete multiple-arch buttress dam with 9 buttresses and 10 arches. The dam crest is 205 m long, maximum dam height is 205 m, and the thickness of the arches ranges from 0.40 to 0.50 m. Due to various stresses and climatic influences, the reinforced concrete arches experienced damages, especially at locations of their contact with buttresses. Due to this fact, it was decided in 2000 to start research activities and preparation of technical documentation with the aim to find the best solution for rehabilitation of the dam. During the first phase of the rehabilitation works the arches 1, 2 and 3 were repaired, and in the second phase the dam foundation and the arches 8, 9 and 10 were repaired.
